HITACHI EX3600-6 EXCAVATOR EX37 (MSP5888) BOOM (INITIAL)

Hitachi EX3600-6 Excavator EX37 (MSP5888) Boom (Initial) - NDT and Examination Report - 17611183

18 Jun 2024

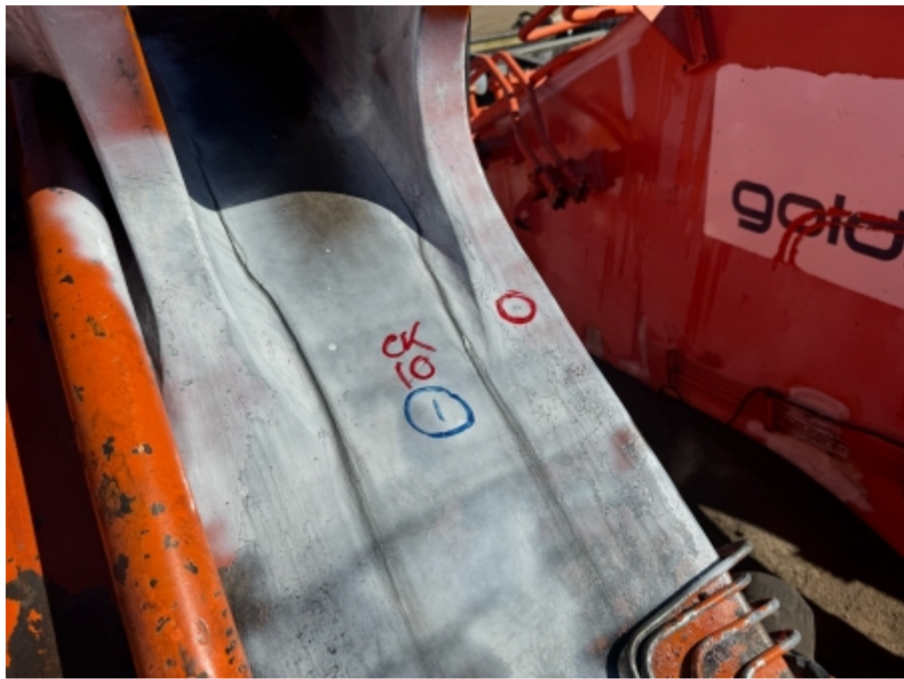
ID Number	Location / Description	Length (mm) / QTY (Ea)	Finding Type	Repairs and Compliance	Finding Photo
1	Top Side Middle	10	Crack (CK)	CNA

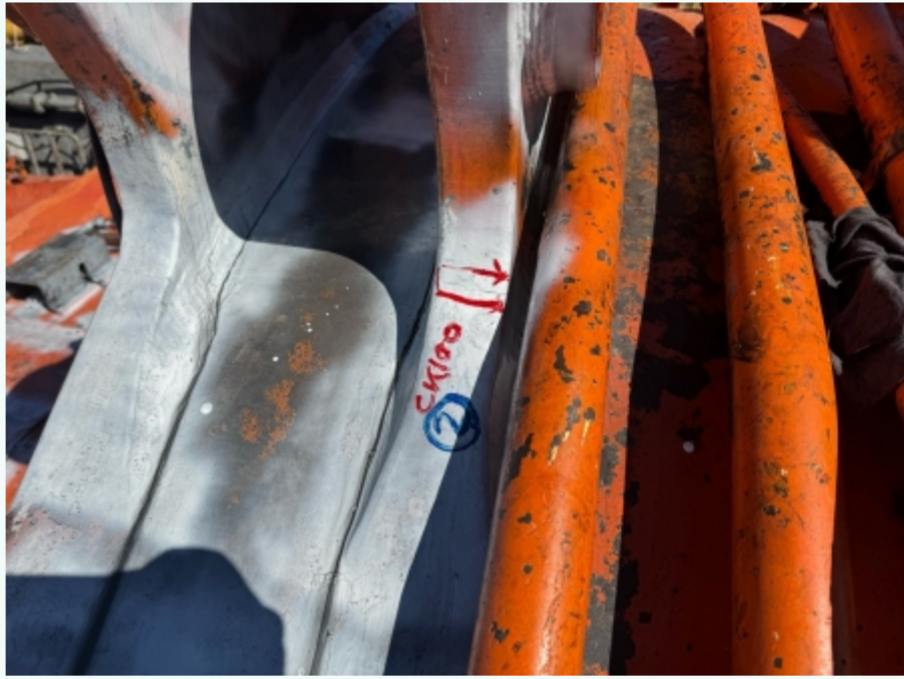
2	Top Side Middle	10	Crack (CK)	CNA

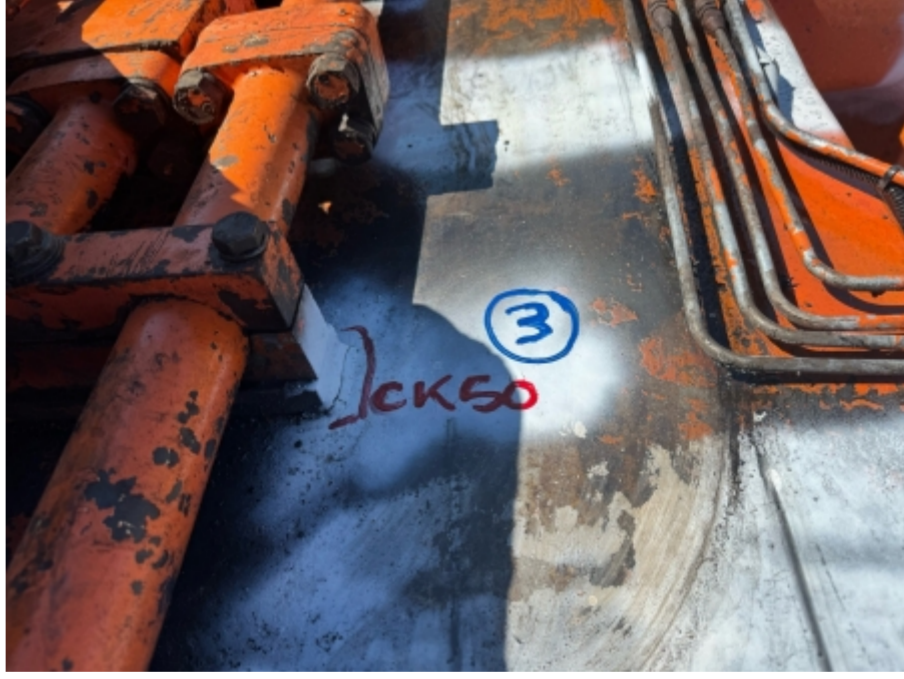
3	Top Side Middle	50	Crack (CK)	CNA

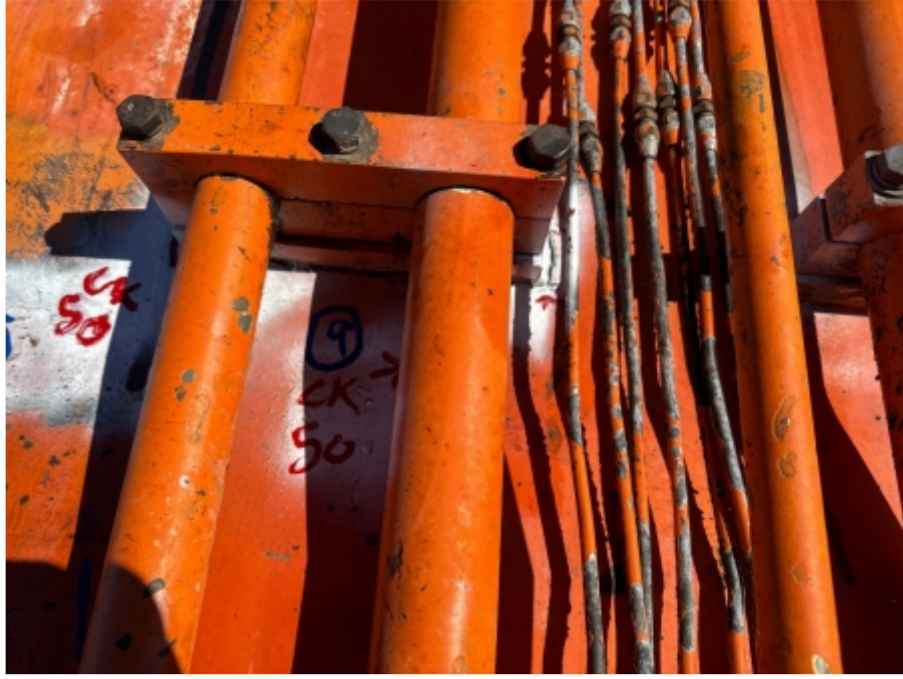
ID Number	Location / Description	Length (mm) / QTY (Ea)	Finding Type	Repairs and Compliance	Finding Photo
9	Top Side Front	50	Crack (CK)	CNA

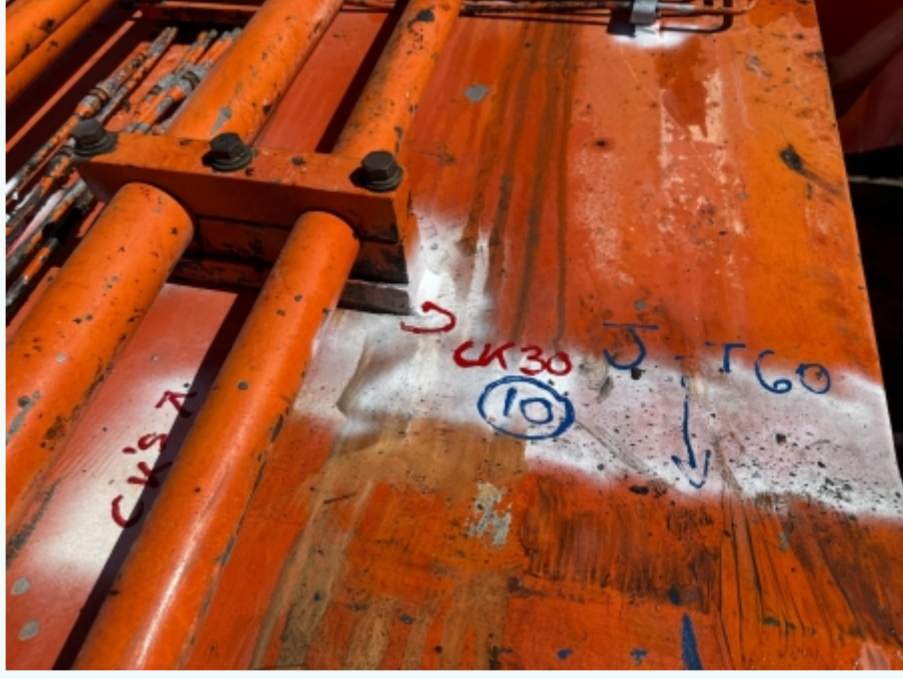
10	Top Side Front	30	Crack (CK)	CNA

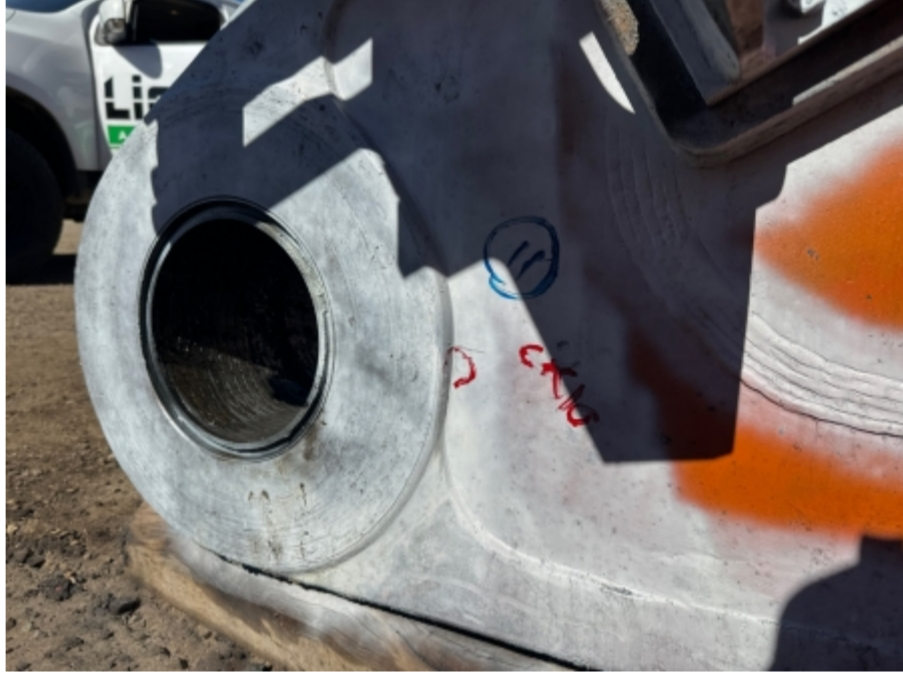
11	Left Hand Side Front	10	Crack (CK)	CNA

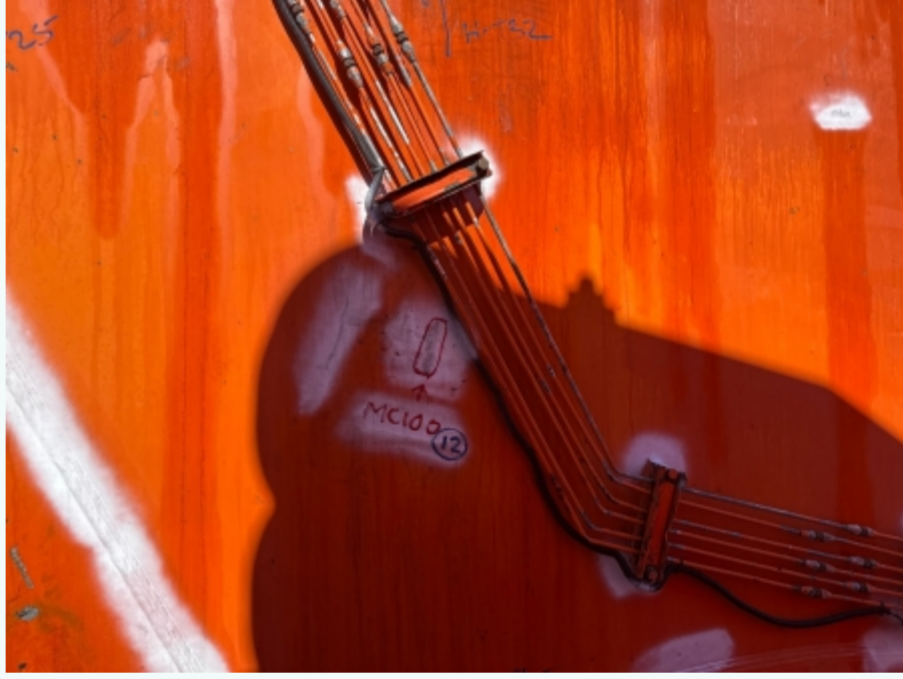
12	Left Hand Side Middle	100	Multiple Cracks (MC)	CNA

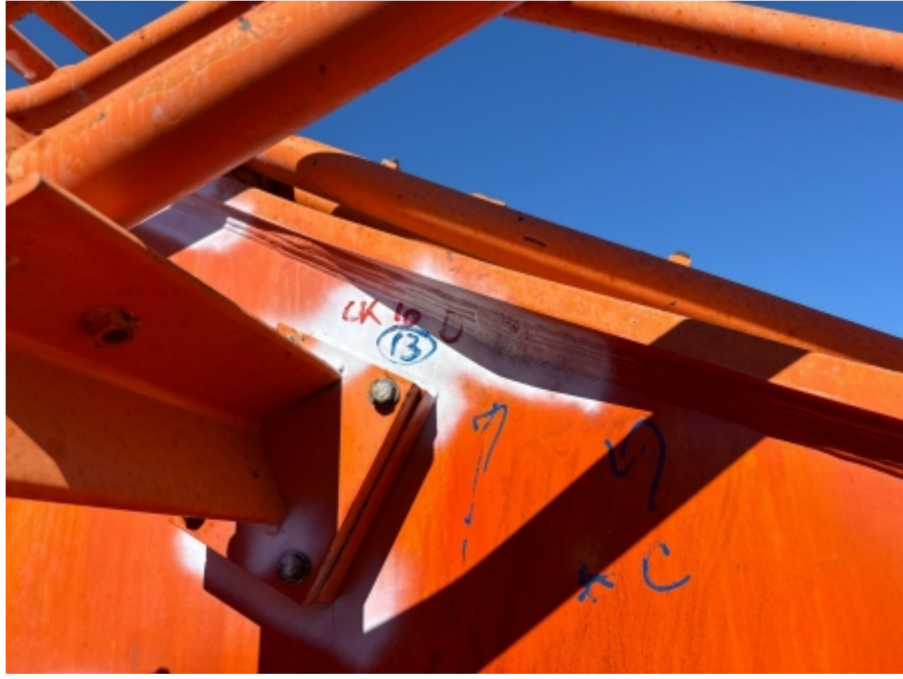
13	Left Hand Side Rear	10	Crack (CK)	CNA

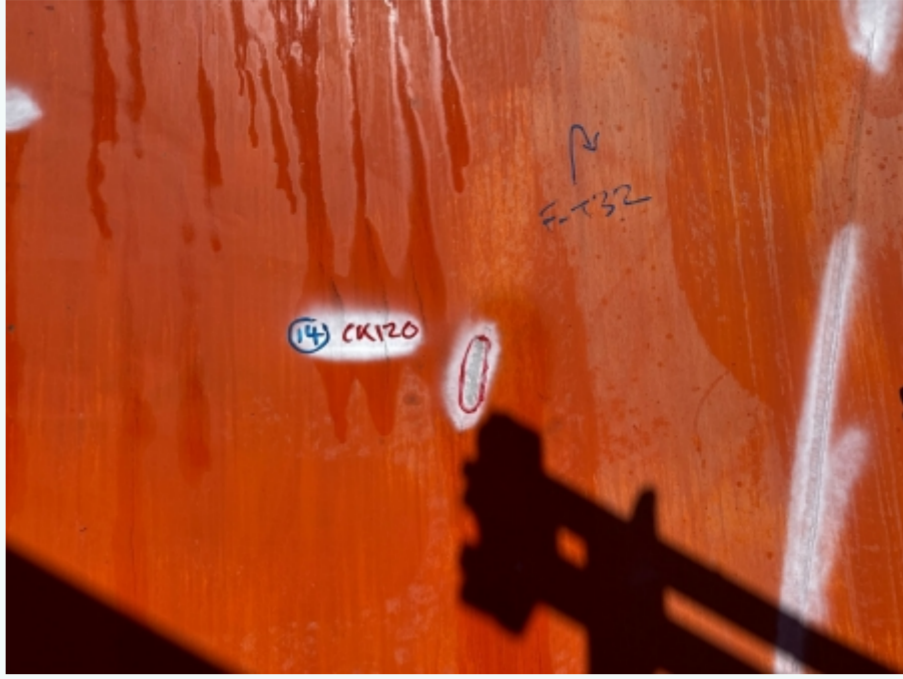
ID Number	Location / Description	Length (mm) / QTY (Ea)	Finding Type	Repairs and Compliance	Finding Photo
14	Left Hand Side Middle	120	Crack (CK)	CNA

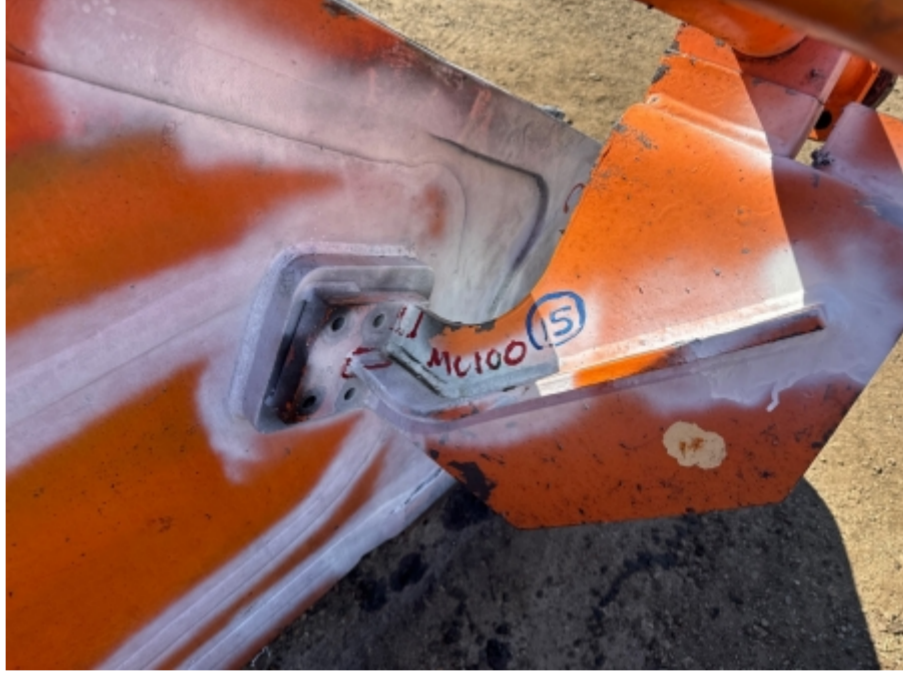
15	Right Hand Side Front	100	Multiple Cracks (MC)	CNA

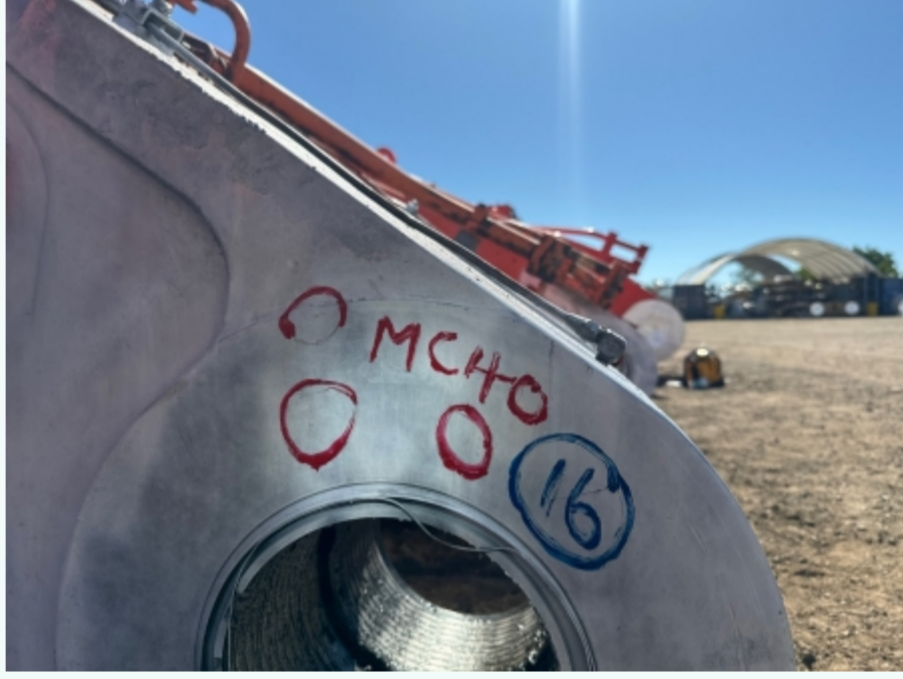
16	Right Hand Side Front	40	Multiple Cracks (MC)	CNA

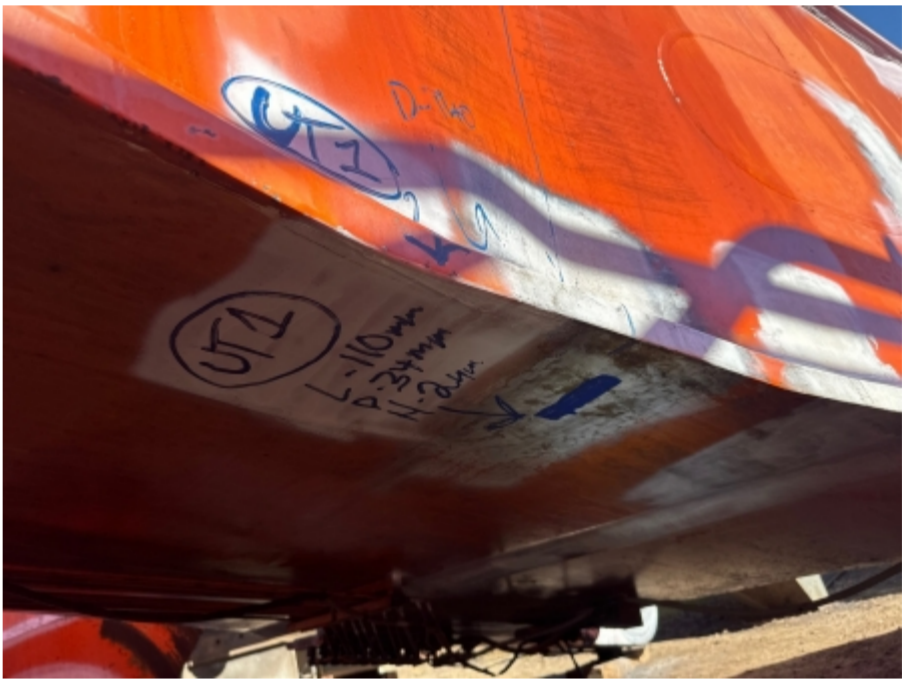
ID Number	Location / Description	Length (mm) / QTY (Ea)	Depth from Surface (mm)	Crack Height (mm)	Finding Type	Repairs and Compliance	Finding Photo
1	Hitachi EX3600 UT Document KO-235(B)-00 Point - D (Bottom Side Rear LHS)	110	34	2	Crack (CK)	CNA

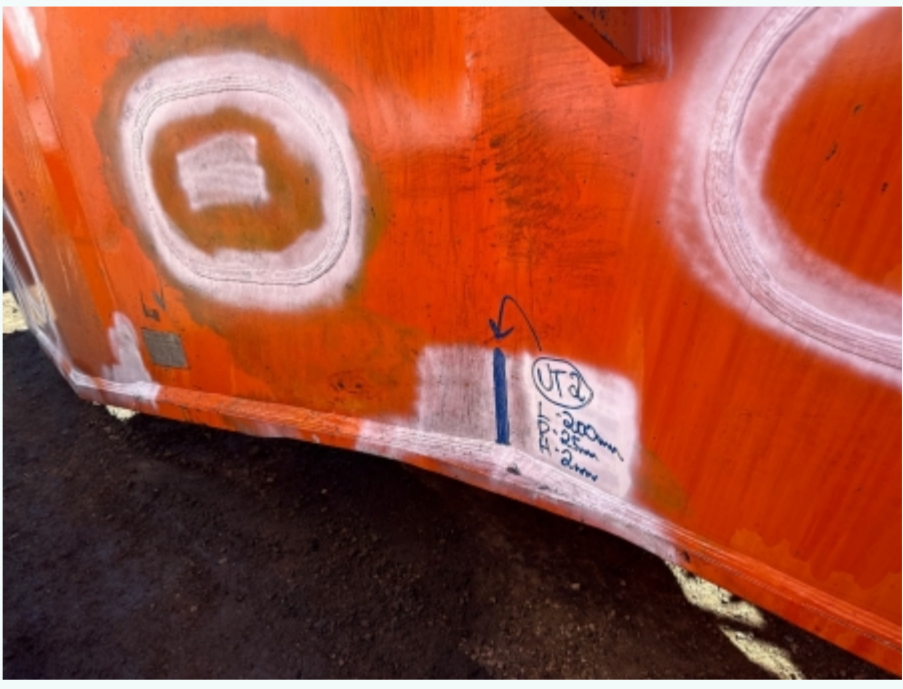
2	Hitachi EX3600 UT Document KO-235(B)-00 Point - E (Right Hand Side Rear)	200	25	2	Crack (CK)	CNA
