HITACHI EX3600-6BE EXCAVATOR EX43 (MSP5228) STICK (INITIAL)

Hitachi EX3600-6BE Excavator EX43 (MSP5288) Stick (Initial) - NDT and Examination Report - 17611206

18 Jun 2024

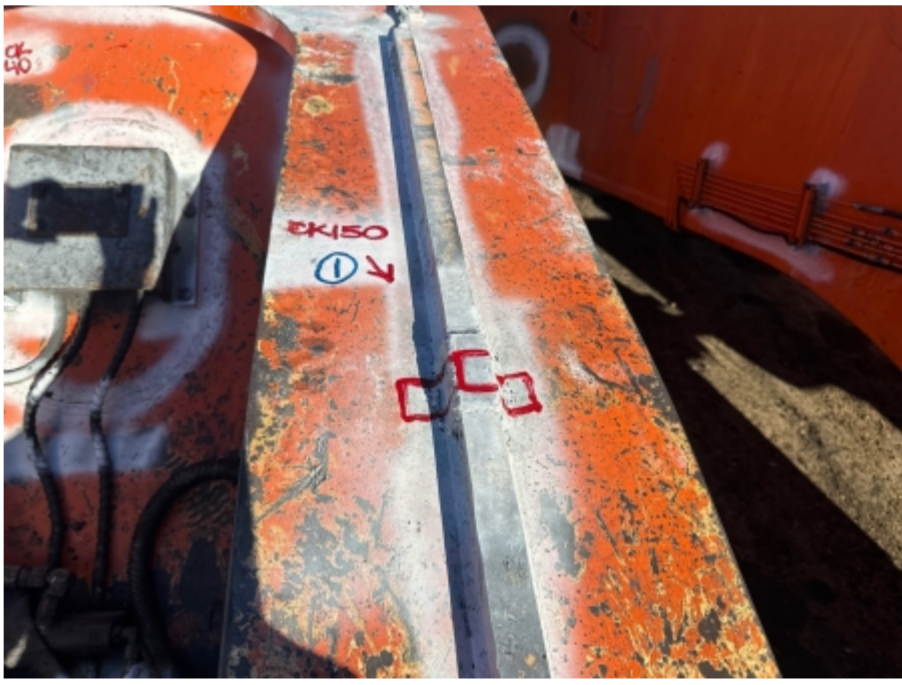
ID Number	Location / Description	Length (mm) / QTY (Ea)	Finding Type	Repairs and Compliance	Finding Photo
1	Top Side LHS	150	Crack (CK)	CNA

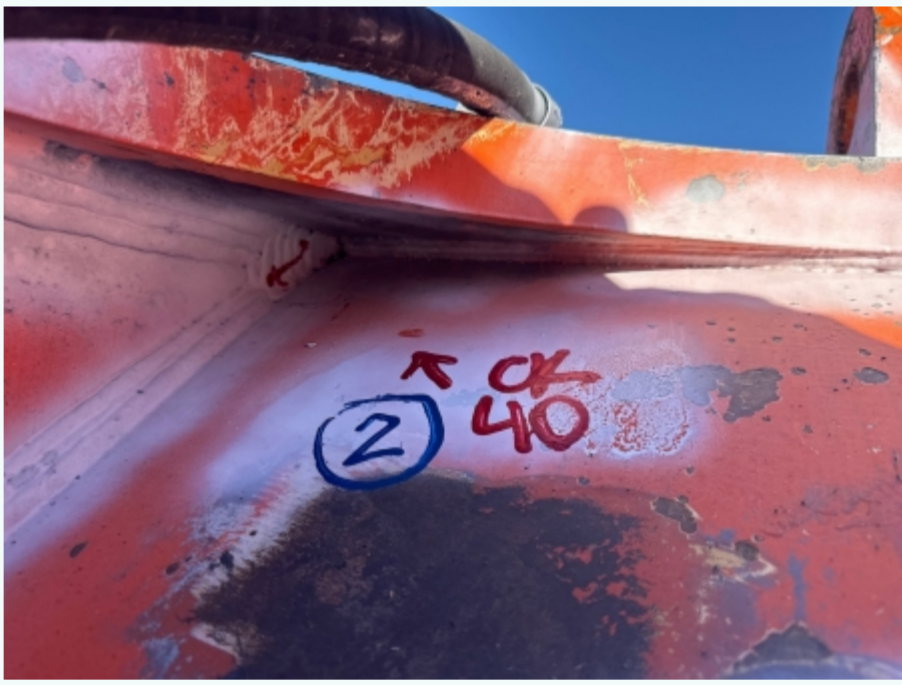
2	Front RHS Inboard	40	Crack (CK)	CNA

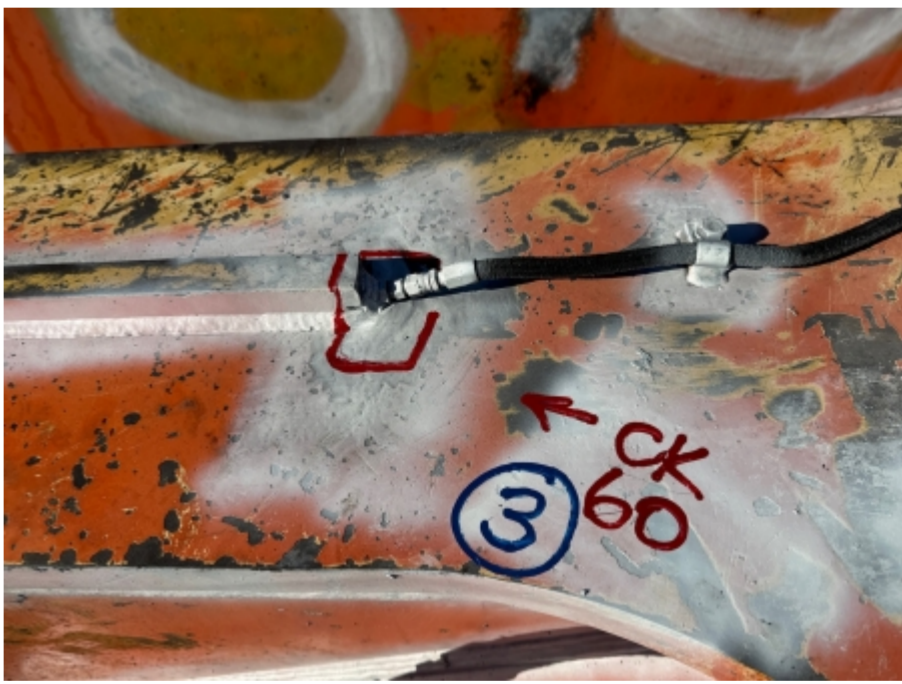
3	Top Side RHS	60	Crack (CK)	CNA

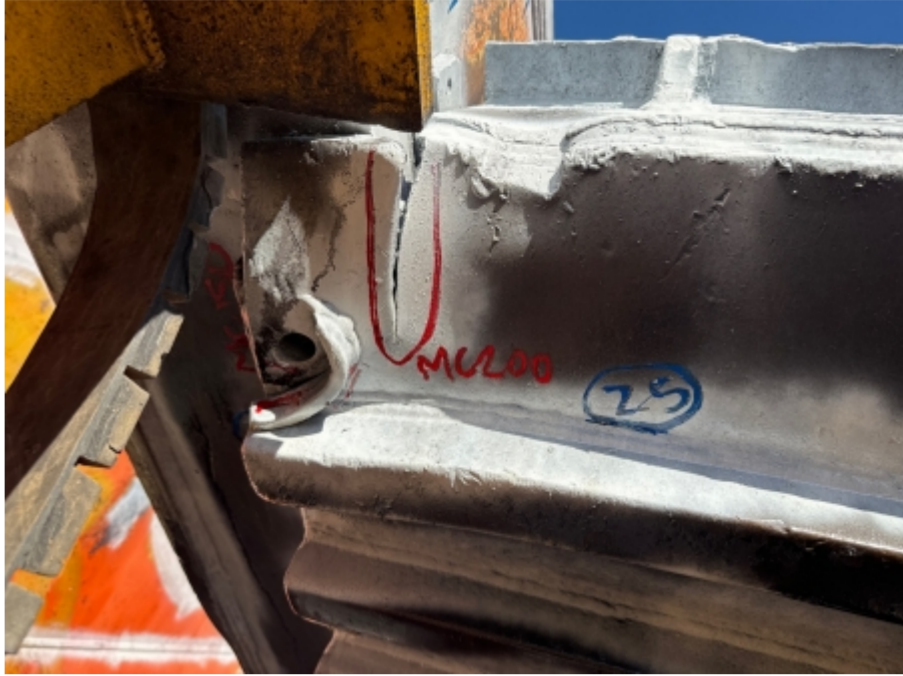
ID Number	Location / Description	Length (mm) / QTY (Ea)	Finding Type	Repairs and Compliance	Finding Photo
25	Under Side Front	200	Multiple Cracks (MC)	CNA

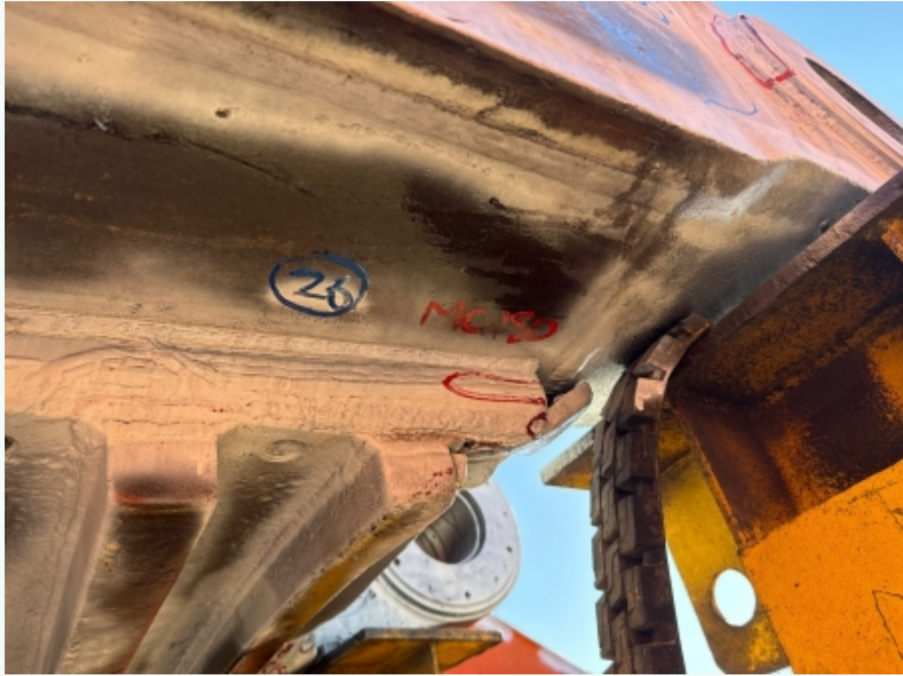
26	Under Side Front	150	Multiple Cracks (MC)	CNA

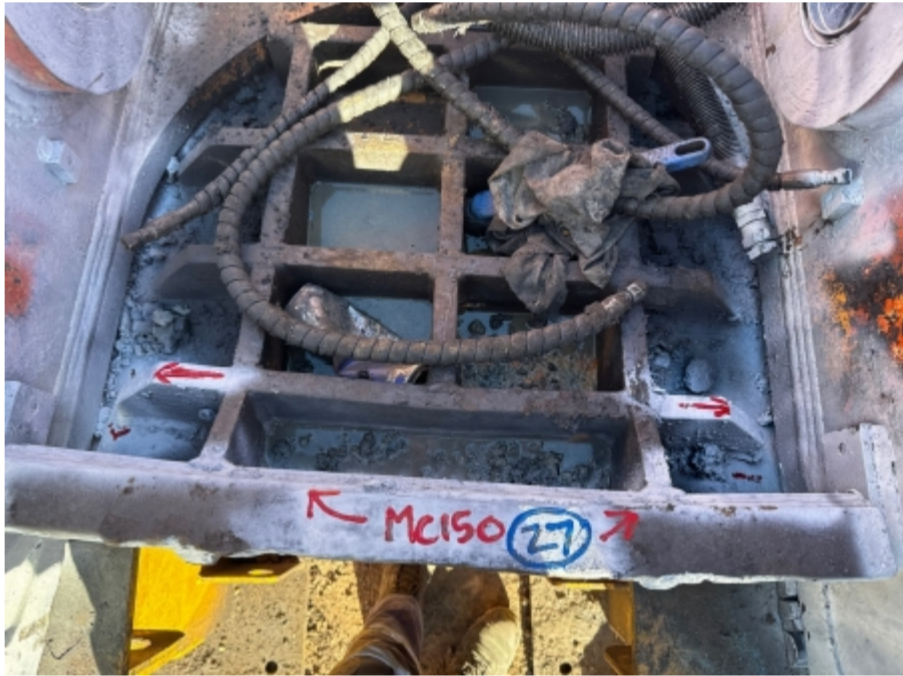
27	Front Inboard	150	Multiple Cracks (MC)	CNA
