HITACHI EX3600-6BE EXCAVATOR EX43 (MSP5287) BOOM (INITIAL)

Hitachi EX3600-6BE Excavator EX43 (MSP5287) Boom (Initial) - NDT and Examination Report - 17611198

18 Jun 2024

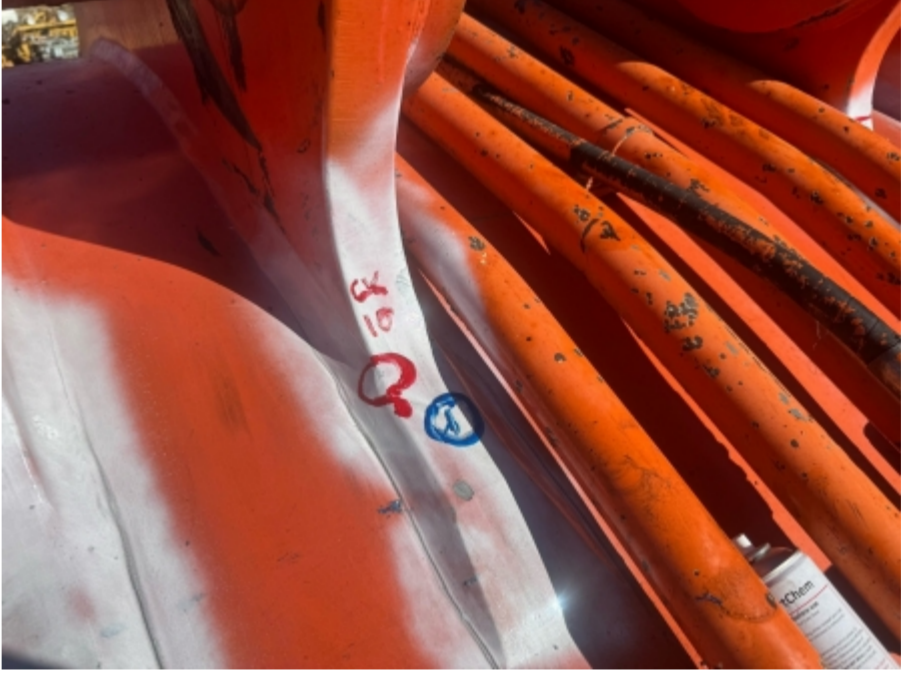
ID Number	Location / Description	Length (mm) / QTY (Ea)	Finding Type	Repairs and Compliance	Finding Photo
1	Top Side Middle	10	Crack (CK)	CNA

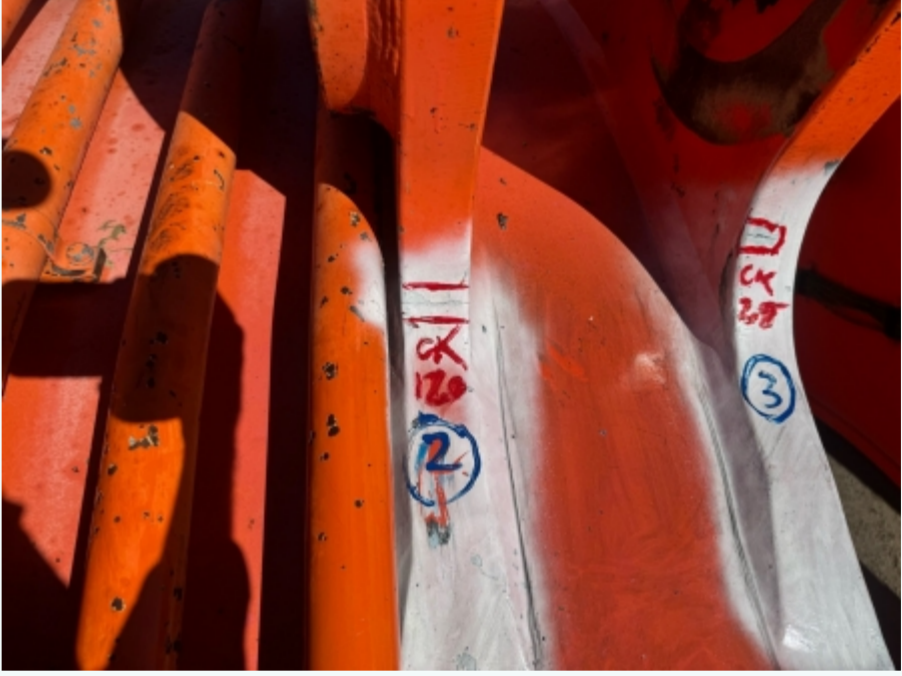
2	Top Side Middle	120	Crack (CK)	CNA

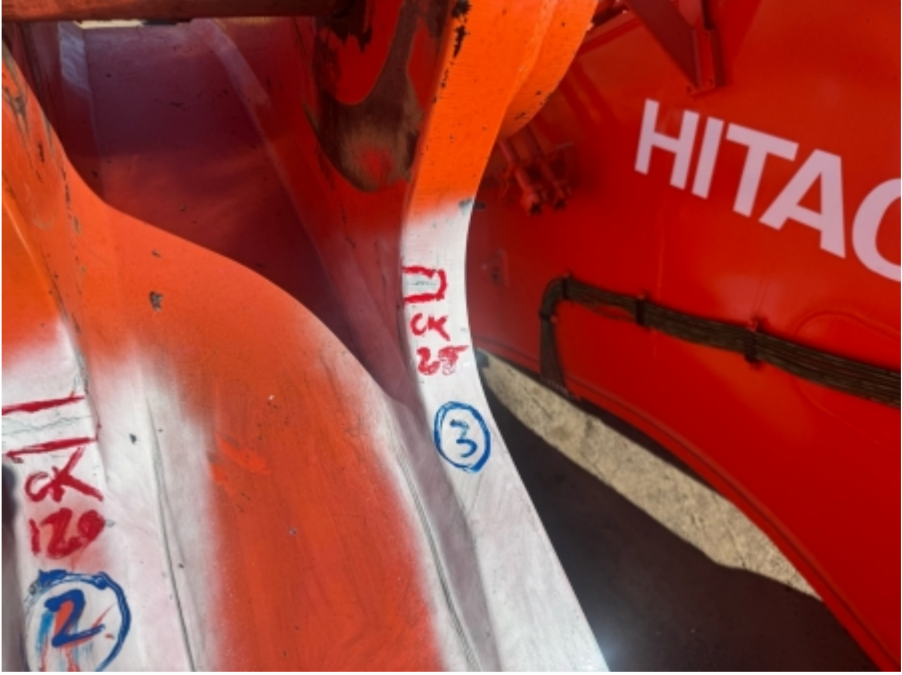
3	Top Side Middle	25	Crack (CK)	CNA

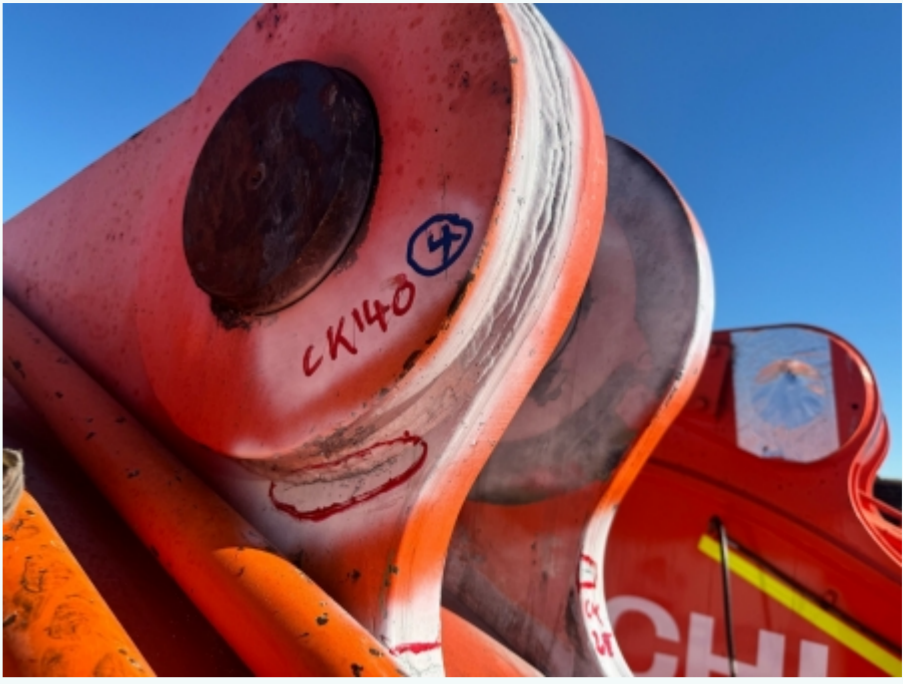
ID Number	Location / Description	Length (mm) / QTY (Ea)	Finding Type	Repairs and Compliance	Finding Photo
4	Top Side Middle	140	Crack (CK)	CNA

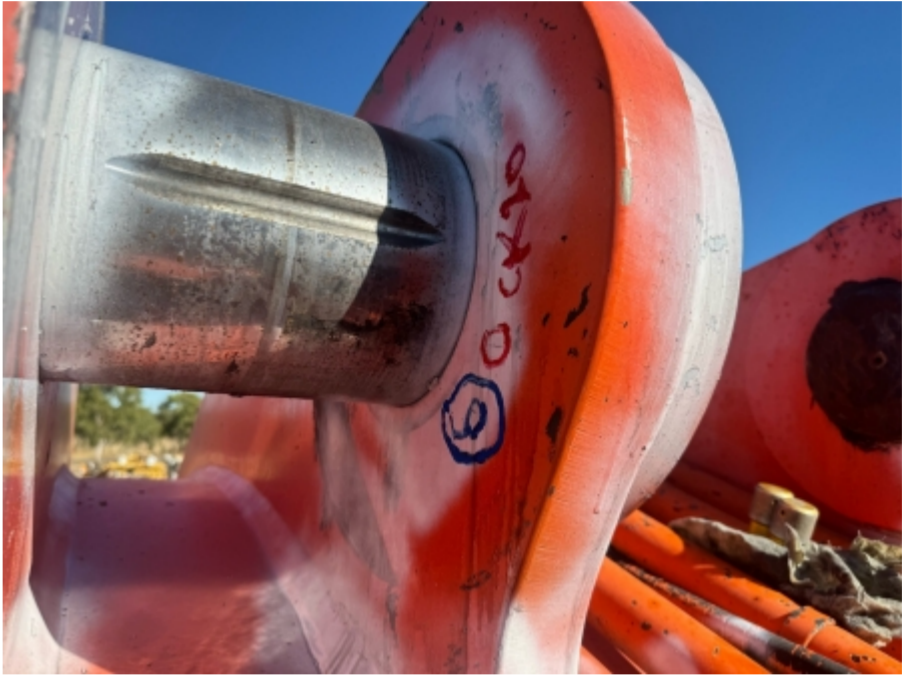
5	Top Side Middle	20	Crack (CK)	CNA

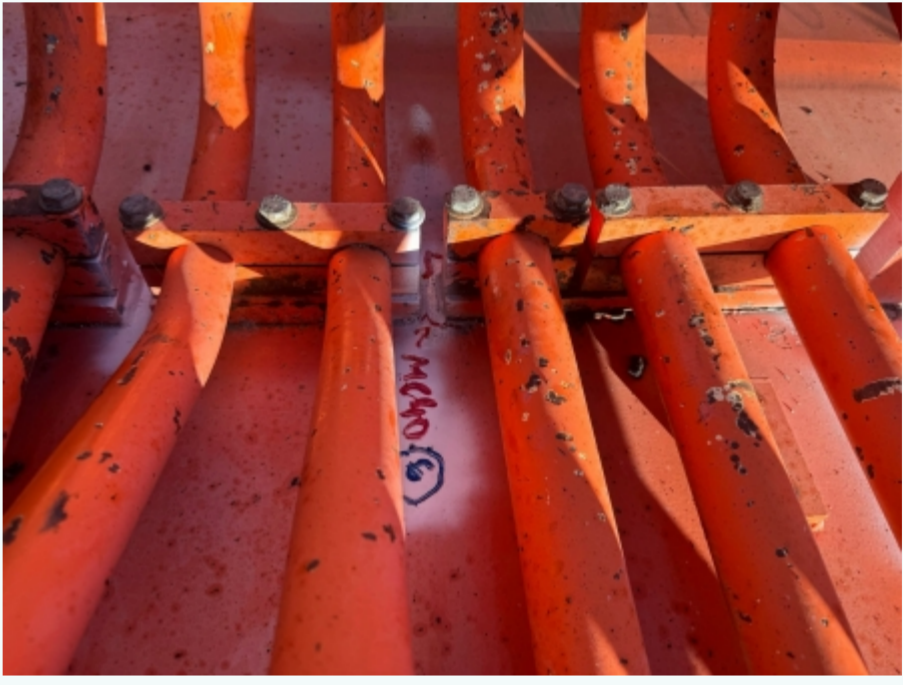
6	Top Side Rear	40	Multiple Cracks (MC)	CNA

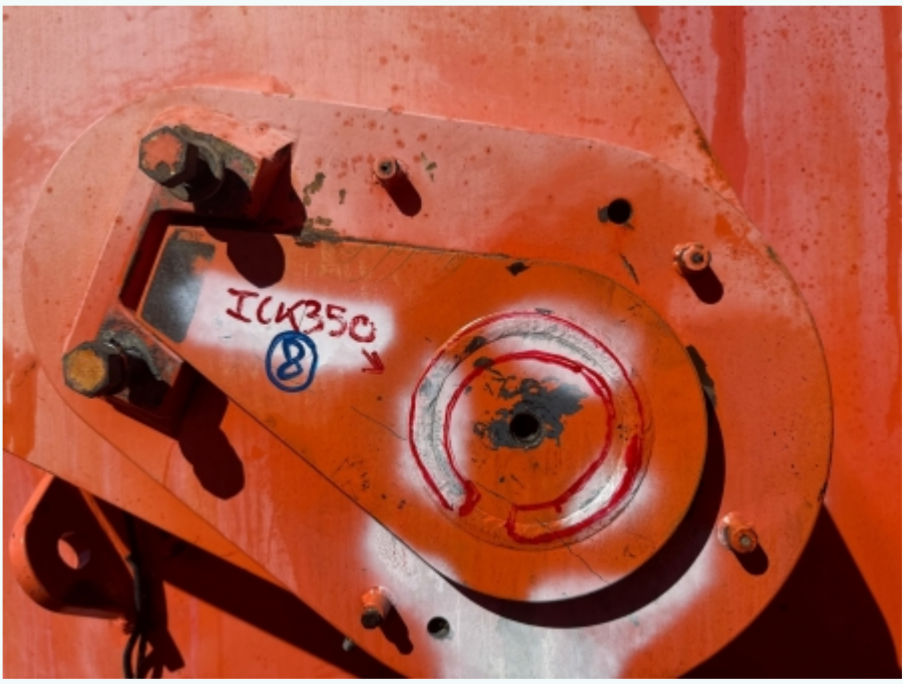
8	Left Hand Side Pin	350	Intermittent Cracking (Int CK)	CNA

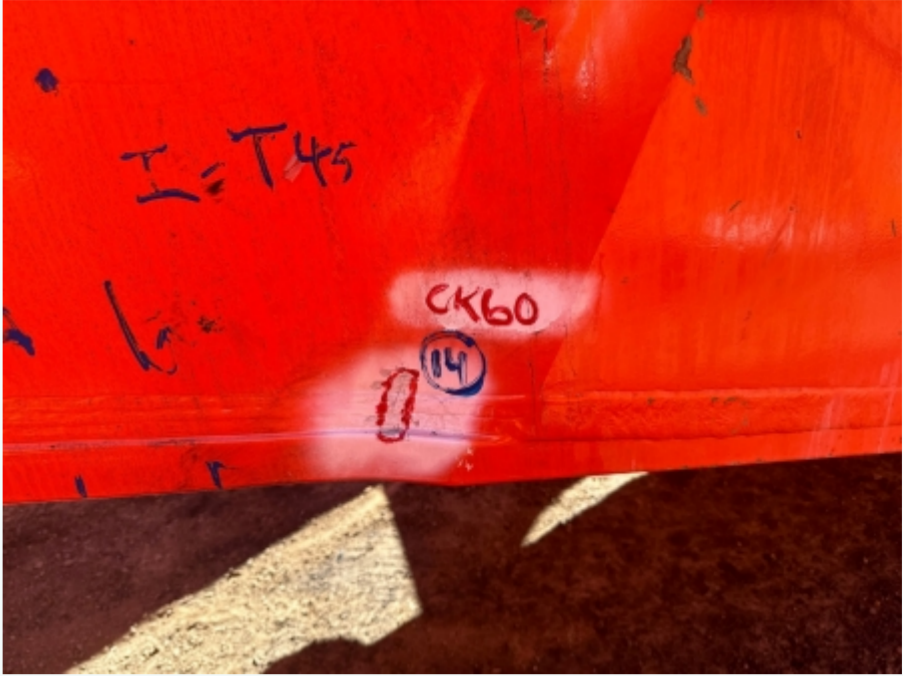
ID Number	Location / Description	Length (mm) / QTY (Ea)	Finding Type	Repairs and Compliance	Finding Photo
14	Right Hand Side Middle	60	Crack (CK)	CNA

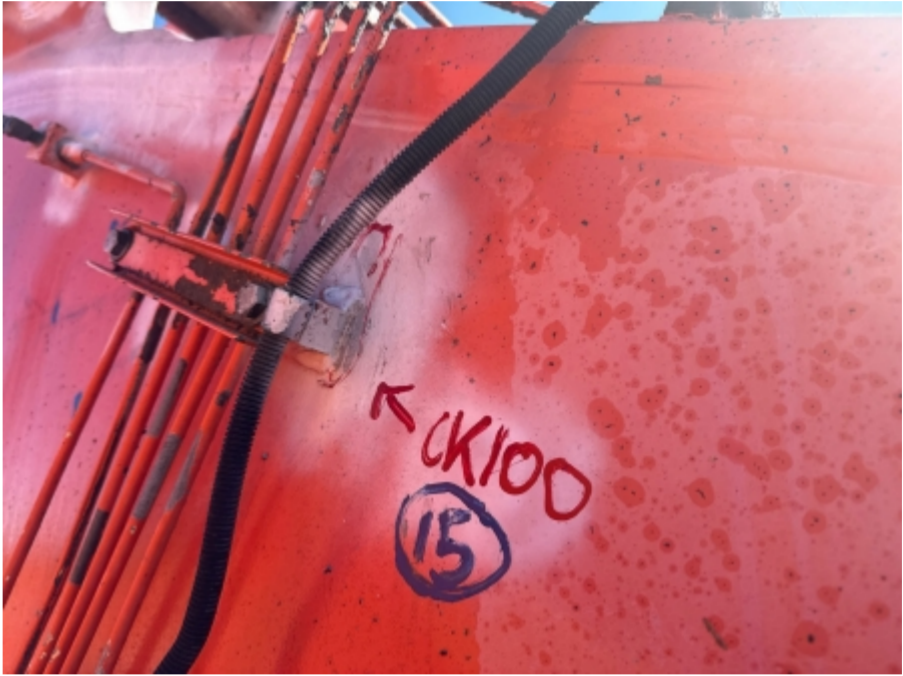
15	Right Hand Side Middle	100	Crack (CK)	CNA
