FLUORESCENT MAGNETIC PARTICLE AND DYE PENETRANT INSPECTION REPORT

JOB NO:	O754 777F Final Drive	REPORT No:	A2404-076
CLIENT:	Hunter Valley Rebuild Centre	TEST DATE:	4 April 2024
CONTACT:	Corey O'Connor	ORDER NO:	PO2349
LOCATION:	27 Kyle St, Rutherford	REPORT DATE:	4 April 2024
SUBJECT:	100% of accessible surfaces	TECHNICIAN:	Geoffery Abbott

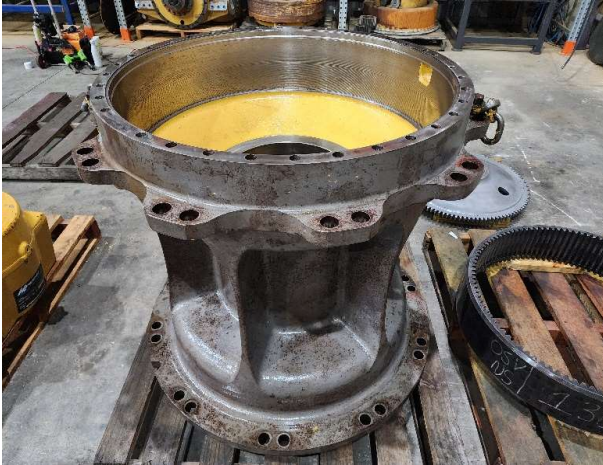
Description of Component Inspected	Results
Job No: O754 Project: 777F Final Drive Item: Barrel	No cracking detected
Job No: O754 Project: 777F Final Drive Item: Spindle	No cracking detected
Job No: O754 Project: 777F Final Drive Item: Anchor Gear	No cracking detected
Job No: O754 Project: 777F Final Drive Item: Ring Gear	No cracking detected

Photo 1 - Overview of Hub inspected.

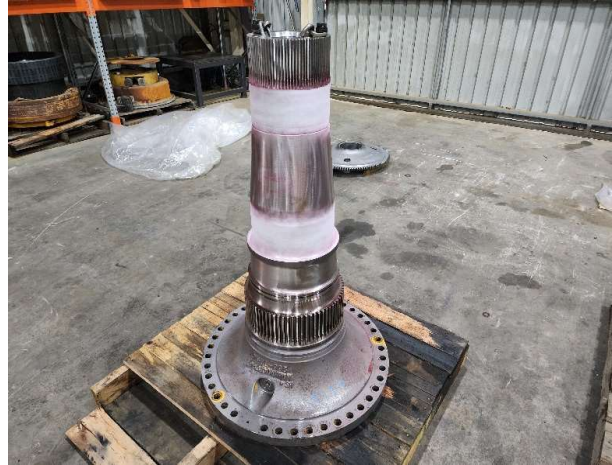
Photo 2 - Overview of Spindle inspected. Bearing journals sprayed white indicate extent of Dye Penetrant Testing.

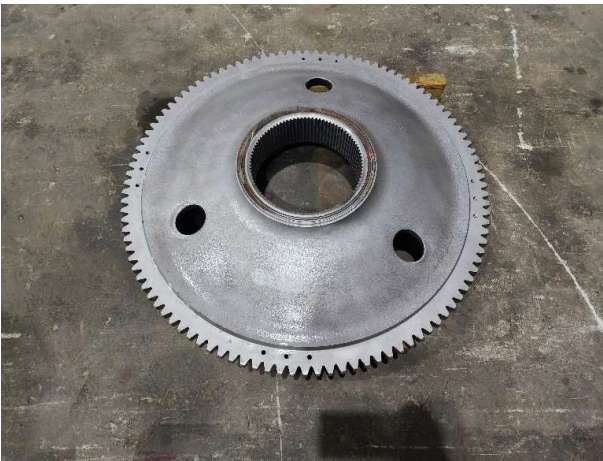
Photo 3 - Overview of Anchor Gear.

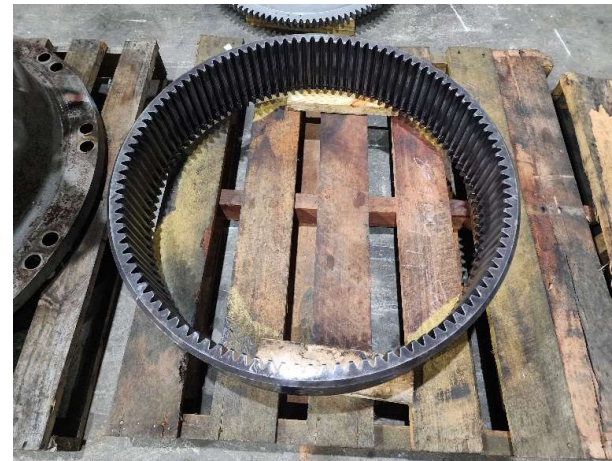
Photo 4 - Overview of Ring Gear.
