FLUORESCENT MAGNETIC PARTICLE AND DYE PENETRANT INSPECTION REPORT

| JOB NO: | O755 | 777F Final Drive | REPORT No: | A2404-077 |
| CLIENT: | Hunter Valley Rebuild Centre | | TEST DATE: | 4 April 2024 |

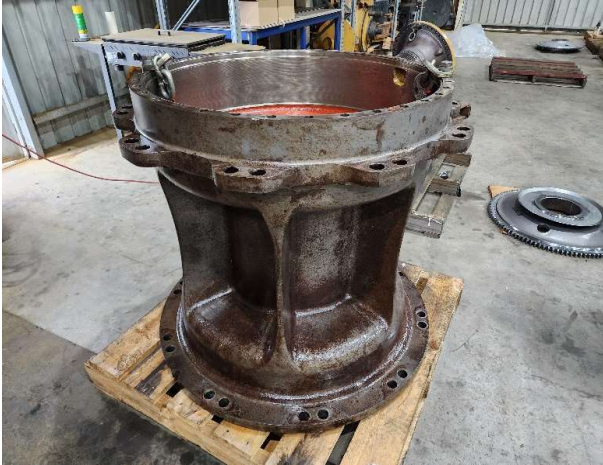
| Description of Component Inspected | Results |
|---|---|
| Job No: O755 Project: 777F Final Drive Item: Barrel | No cracking detected |

Photo 1 - Overview of Hub inspected.

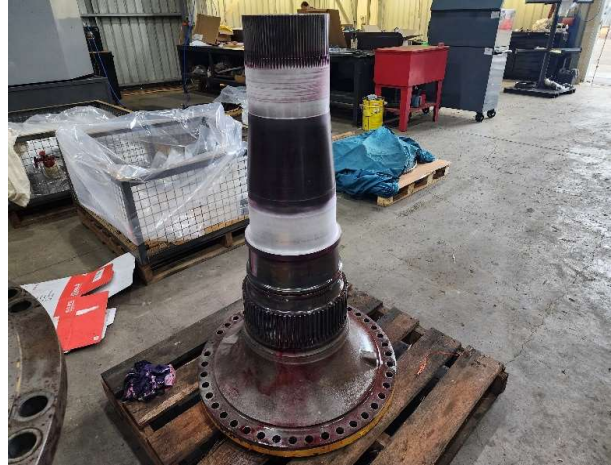
| Description of Component Inspected | Results |
|---|---|
| Job No: O755 Project: 777F Final Drive Item: Spindle | No cracking detected |

Photo 2 - Overview of Spindle inspected. Bearing journals sprayed white indicate extent of Dye Penetrant Testing.

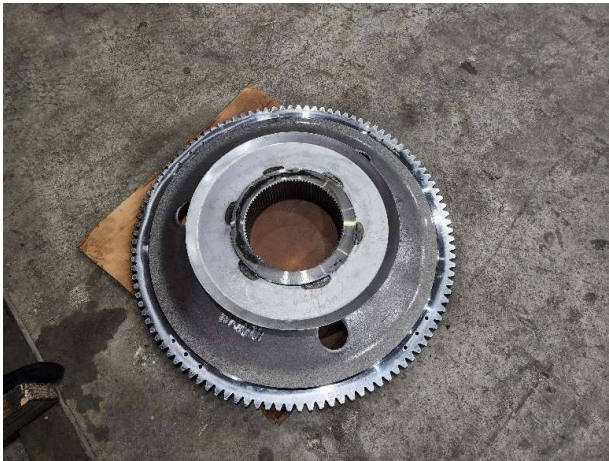
| Description of Component Inspected | Results |
|---|---|
| Job No: O755 Project: 777F Final Drive Item: Anchor Gear | No cracking detected |

Photo 3 - Overview of Anchor Gear.

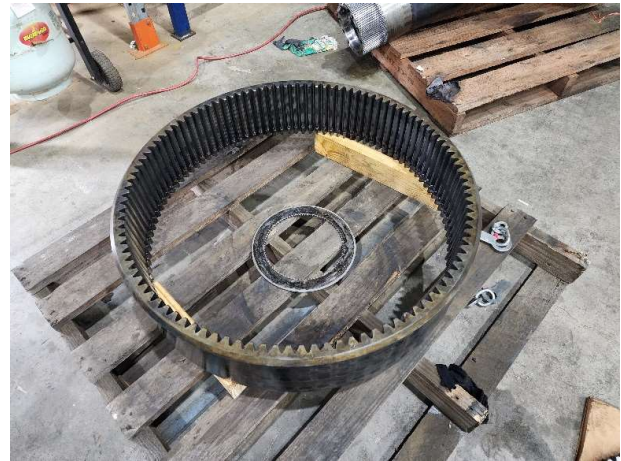
| Description of Component Inspected | Results |
|---|---|
| Job No: O755 Project: 777F Final Drive Item: Ring Gear | No cracking detected |

Photo 4 - Overview of Ring Gear.
