# REPAIRER'S DATA REPORT

**JOB NUMBER: 29044**

**Client:** Minespec Parts Pty Ltd (Qld)

**Description:** Hitachi EX5600-6 Stick / Arm MSP-0005217

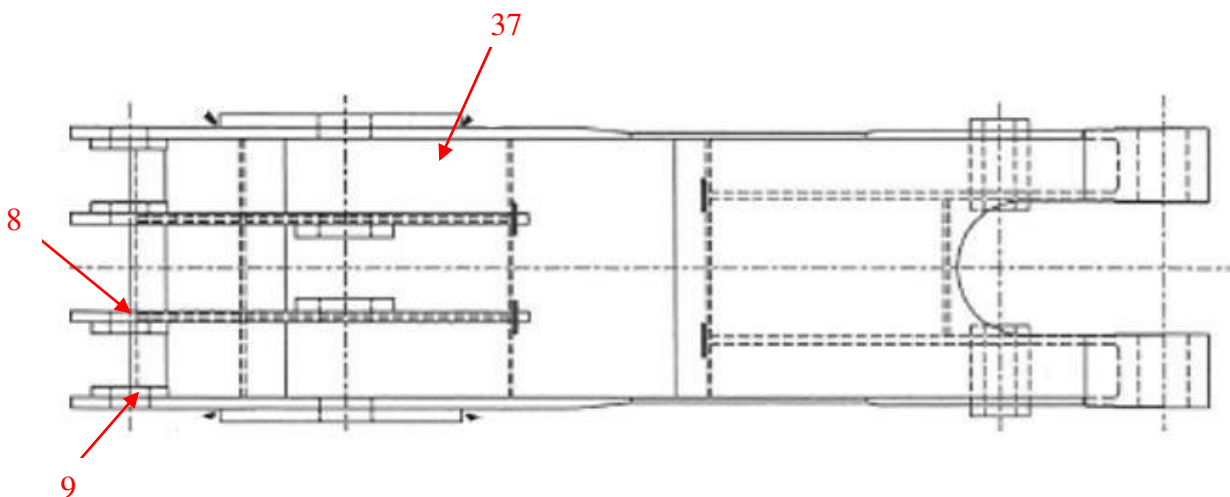
**FIGURE 4 – EXTERNAL BODY UNDERSIDE**

Identification	Total No. of Defects	Total Length of Defects	Interpretation
External Body	37	4450mm	New Cracking Evident

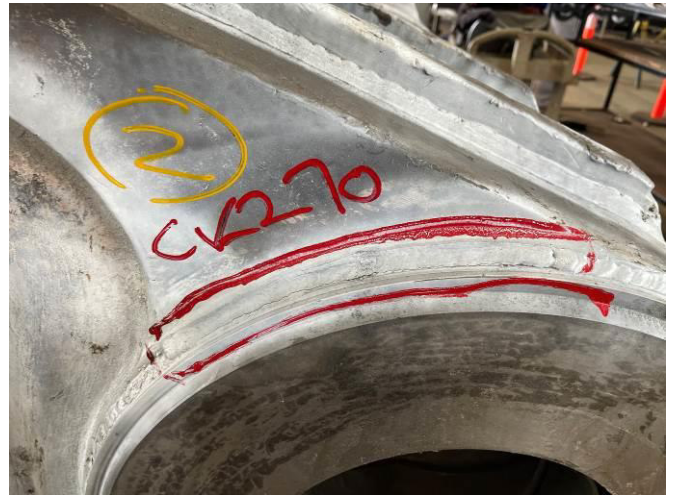
PHOTOGRAPH NO. 2 – EXTERNAL BODY  
TYPICAL VIEW OF DEFECT #2

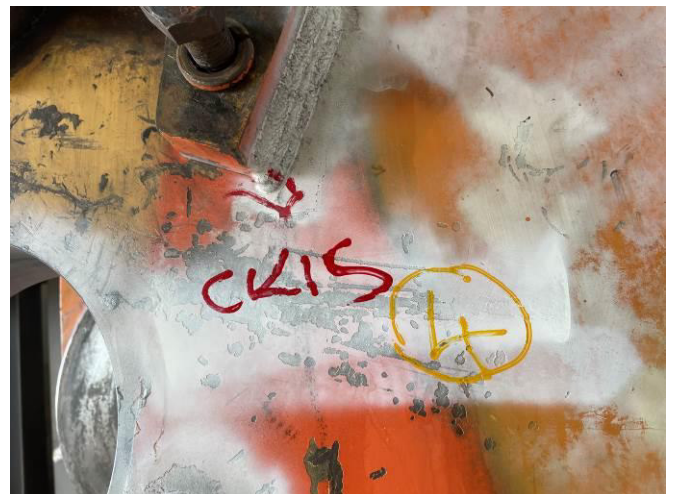
PHOTOGRAPH NO. 4 – EXTERNAL BODY  
TYPICAL VIEW OF DEFECT #4

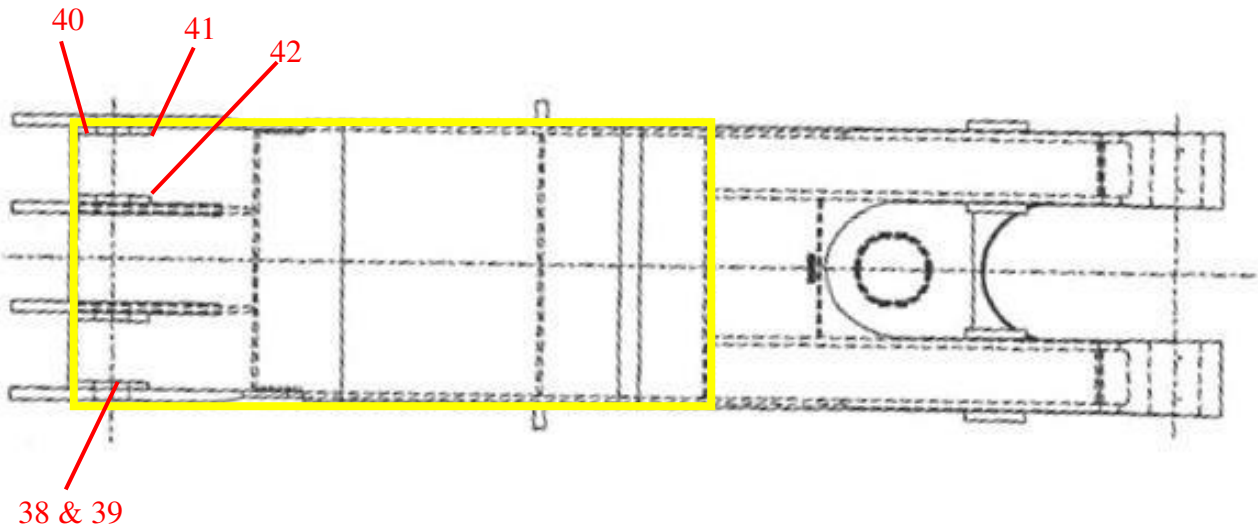
**RESULTS OF EXAMINATION CONTINUED****FIGURE 1 – EXTERNAL TOP SIDE**

Note: Highlighted Area Inspected

Defect No.	Length in mm	Defect No.	Length in mm
No. 38	150	No. 41	300
No. 39	70	No. 42	120
No. 40	20

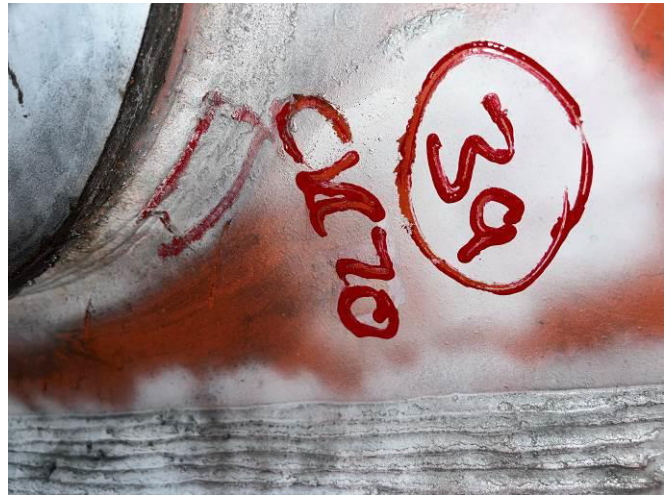
PHOTOGRAPH NO. 2 – EXTERNAL TOP SIDE  
TYPICAL VIEW OF DEFECT #39

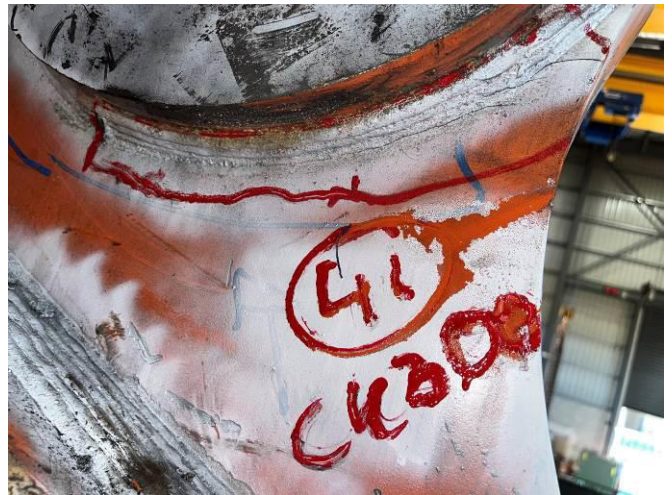
PHOTOGRAPH NO. 4 – EXTERNAL TOP SIDE  
TYPICAL VIEW OF DEFECT #41

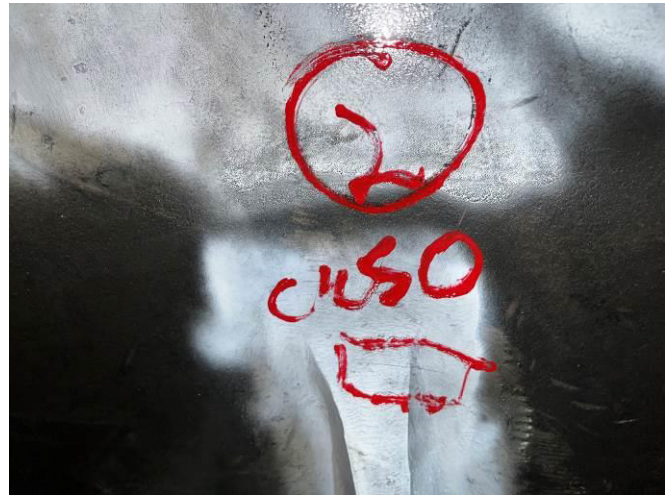
PHOTOGRAPH NO. 8 – INTERNAL BAY ‘B’  
TYPICAL VIEW OF DEFECT #2

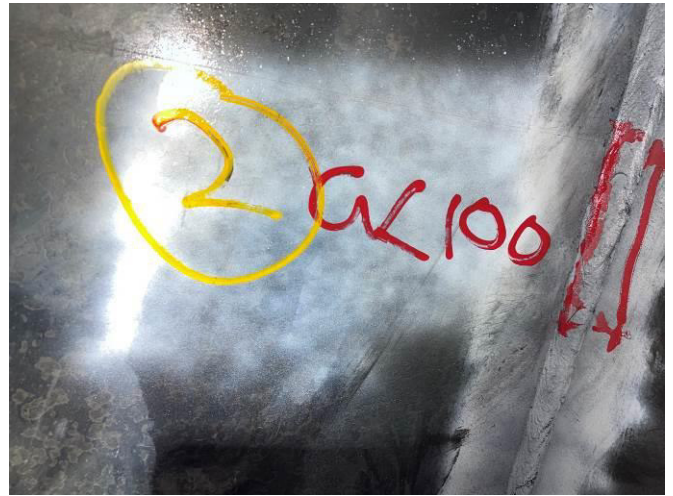
PHOTOGRAPH NO. 13 – INTERNAL BAY ‘C’  
TYPICAL VIEW OF DEFECT #2

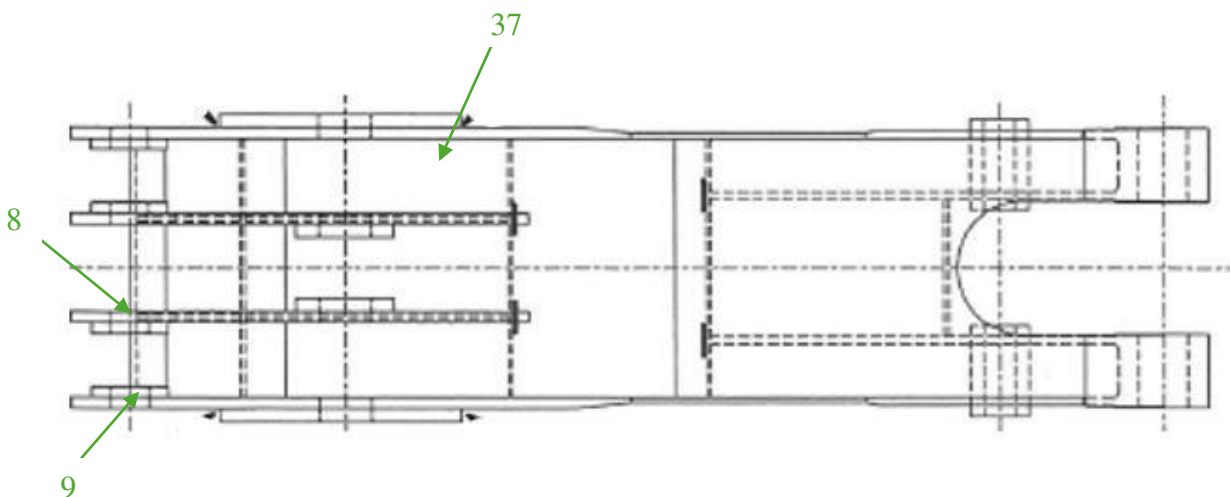
**FIGURE 4 – EXTERNAL STICK UNDERSIDE**

<b>Identification</b>	<b>Total No. of Repairs</b>	<b>Interpretation</b>
External Stick	42	Defects Repaired Since Last Inspection
Internal Bay 'B'	5	Defects Repaired Since Last Inspection
Internal Bay 'C'	34	Defects Repaired Since Last Inspection

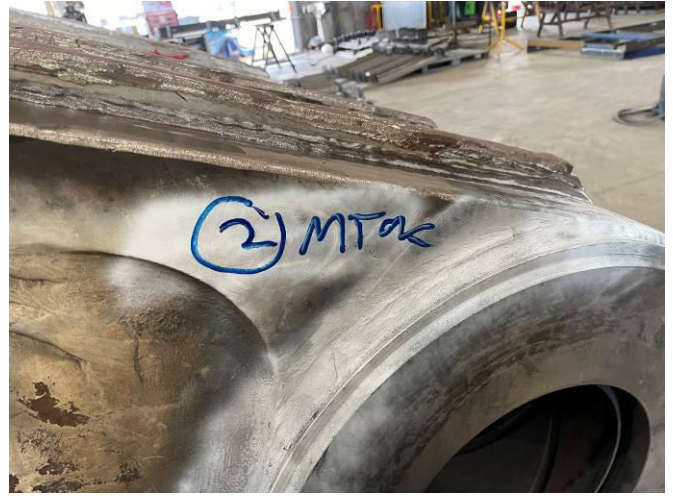
PHOTOGRAPH NO. 2 – EXTERNAL STICK  
TYPICAL VIEW OF REPAIRED DEFECT #2

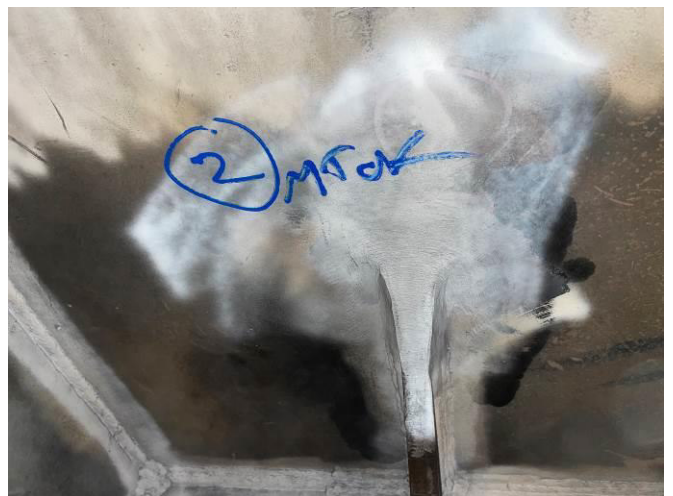
PHOTOGRAPH NO. 44 – INTERNAL BAY ‘B’  
TYPICAL VIEW OF REPAIRED DEFECT #2

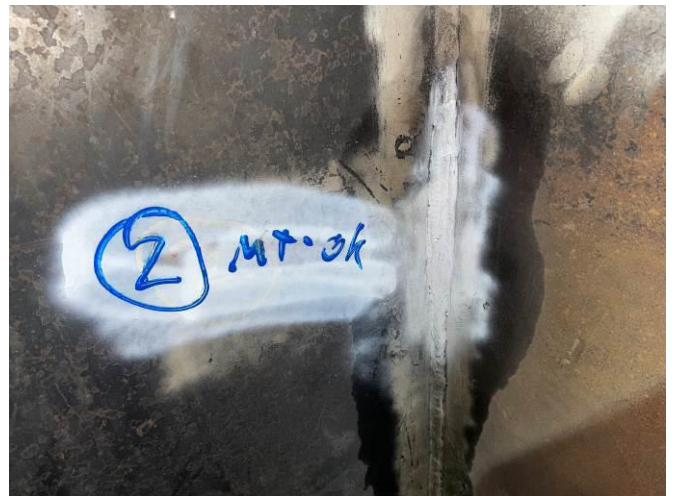
PHOTOGRAPH NO. 49 – INTERNAL BAY ‘C’  
TYPICAL VIEW OF REPAIRED DEFECT #2
